**DEPARTMENT OF TRANSPORTATION**

Contract #: 04-0120F4Cty: SF/ALA Rte: 80 PM: 13.2/13.9File #: 1.28**WELDING INSPECTION REPORT****Resident Engineer:** Casey, William**Address:** 333 Burma Road**City:** Oakland, CA 94607**Report No:** WIR-029796**Date Inspected:** 18-May-2013**Project Name:** SAS Superstructure**OSM Arrival Time:** 700**Prime Contractor:** American Bridge/Fluor Enterprises, a JV**OSM Departure Time:** 1530**Contractor:** American Bridge/Fluor Enterprises, a JV**Location:** Job Site**CWI Name:** Salvador Merino**CWI Present:** Yes No**Inspected CWI report:** Yes No N/A**Rod Oven in Use:** Yes No N/A**Electrode to specification:** Yes No N/A**Weld Procedures Followed:** Yes No N/A**Qualified Welders:** Yes No N/A**Verified Joint Fit-up:** Yes No N/A**Approved Drawings:** Yes No N/A**Approved WPS:** Yes No N/A**Delayed / Cancelled:** Yes No N/A**Bridge No:** 34-0006**Component:** SAS OBG**Summary of Items Observed:**

Caltrans Office of Structural Material (OSM) Quality Assurance Inspector (QAI) Joselito Lizardo was present at the Self Anchored Suspension (SAS) job site as requested to perform observations on the welding of components for the San Francisco Oakland Bay

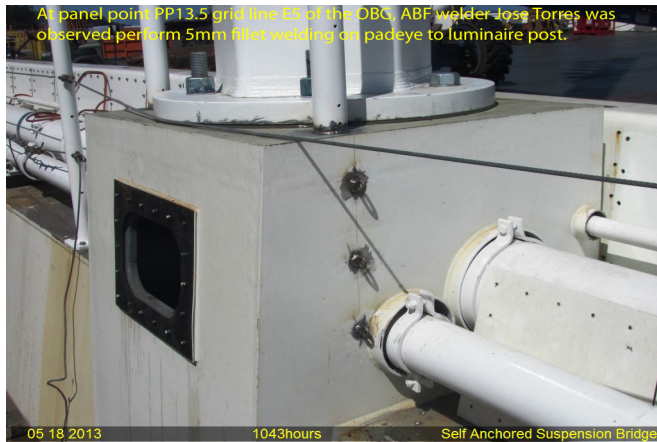
After the completion of the top deck plate walkthrough, this QA has observed ABF welder Jose Torres perform 5mm fillet welding all around padeye to luminaire post. The welder was noted welding using Shielded Metal Arc Welding (SMAW) with 1/8" diameter E7018H4R electrode. The welder was noted welding at location Panel Point PP13.5 E5 of the east bound OBG. During welding, ABF QC William Sherwood was noted monitoring the parameters and workmanship of the welder.
